## SUMMARY OF ANALYSIS CROTON FALLS ROAD AND ROUTE 6

## INTERSECTION EVALUATION WORKSHEET

<b>Project:</b>	Putnam County Roundabout Evaluation
<b>Location:</b>	Putnam County (Various Locations)
<b>Intersection:</b>	Route 6 & Croton Falls Rd
<b>GPS Coord.:</b>	41°22'35.53"N, 73°43'30.22"W
<b>Traffic Control:</b>	Traffic Signal
<b>Traffic Control Notes (if applicable):</b>	2-phase signal. No turn phases.
<b>Other Intersection Notes (if applicable):</b>	NB Right Shoulder designated as Bike Lane. Crosswalks with signals/PB/countdown timers - all approaches

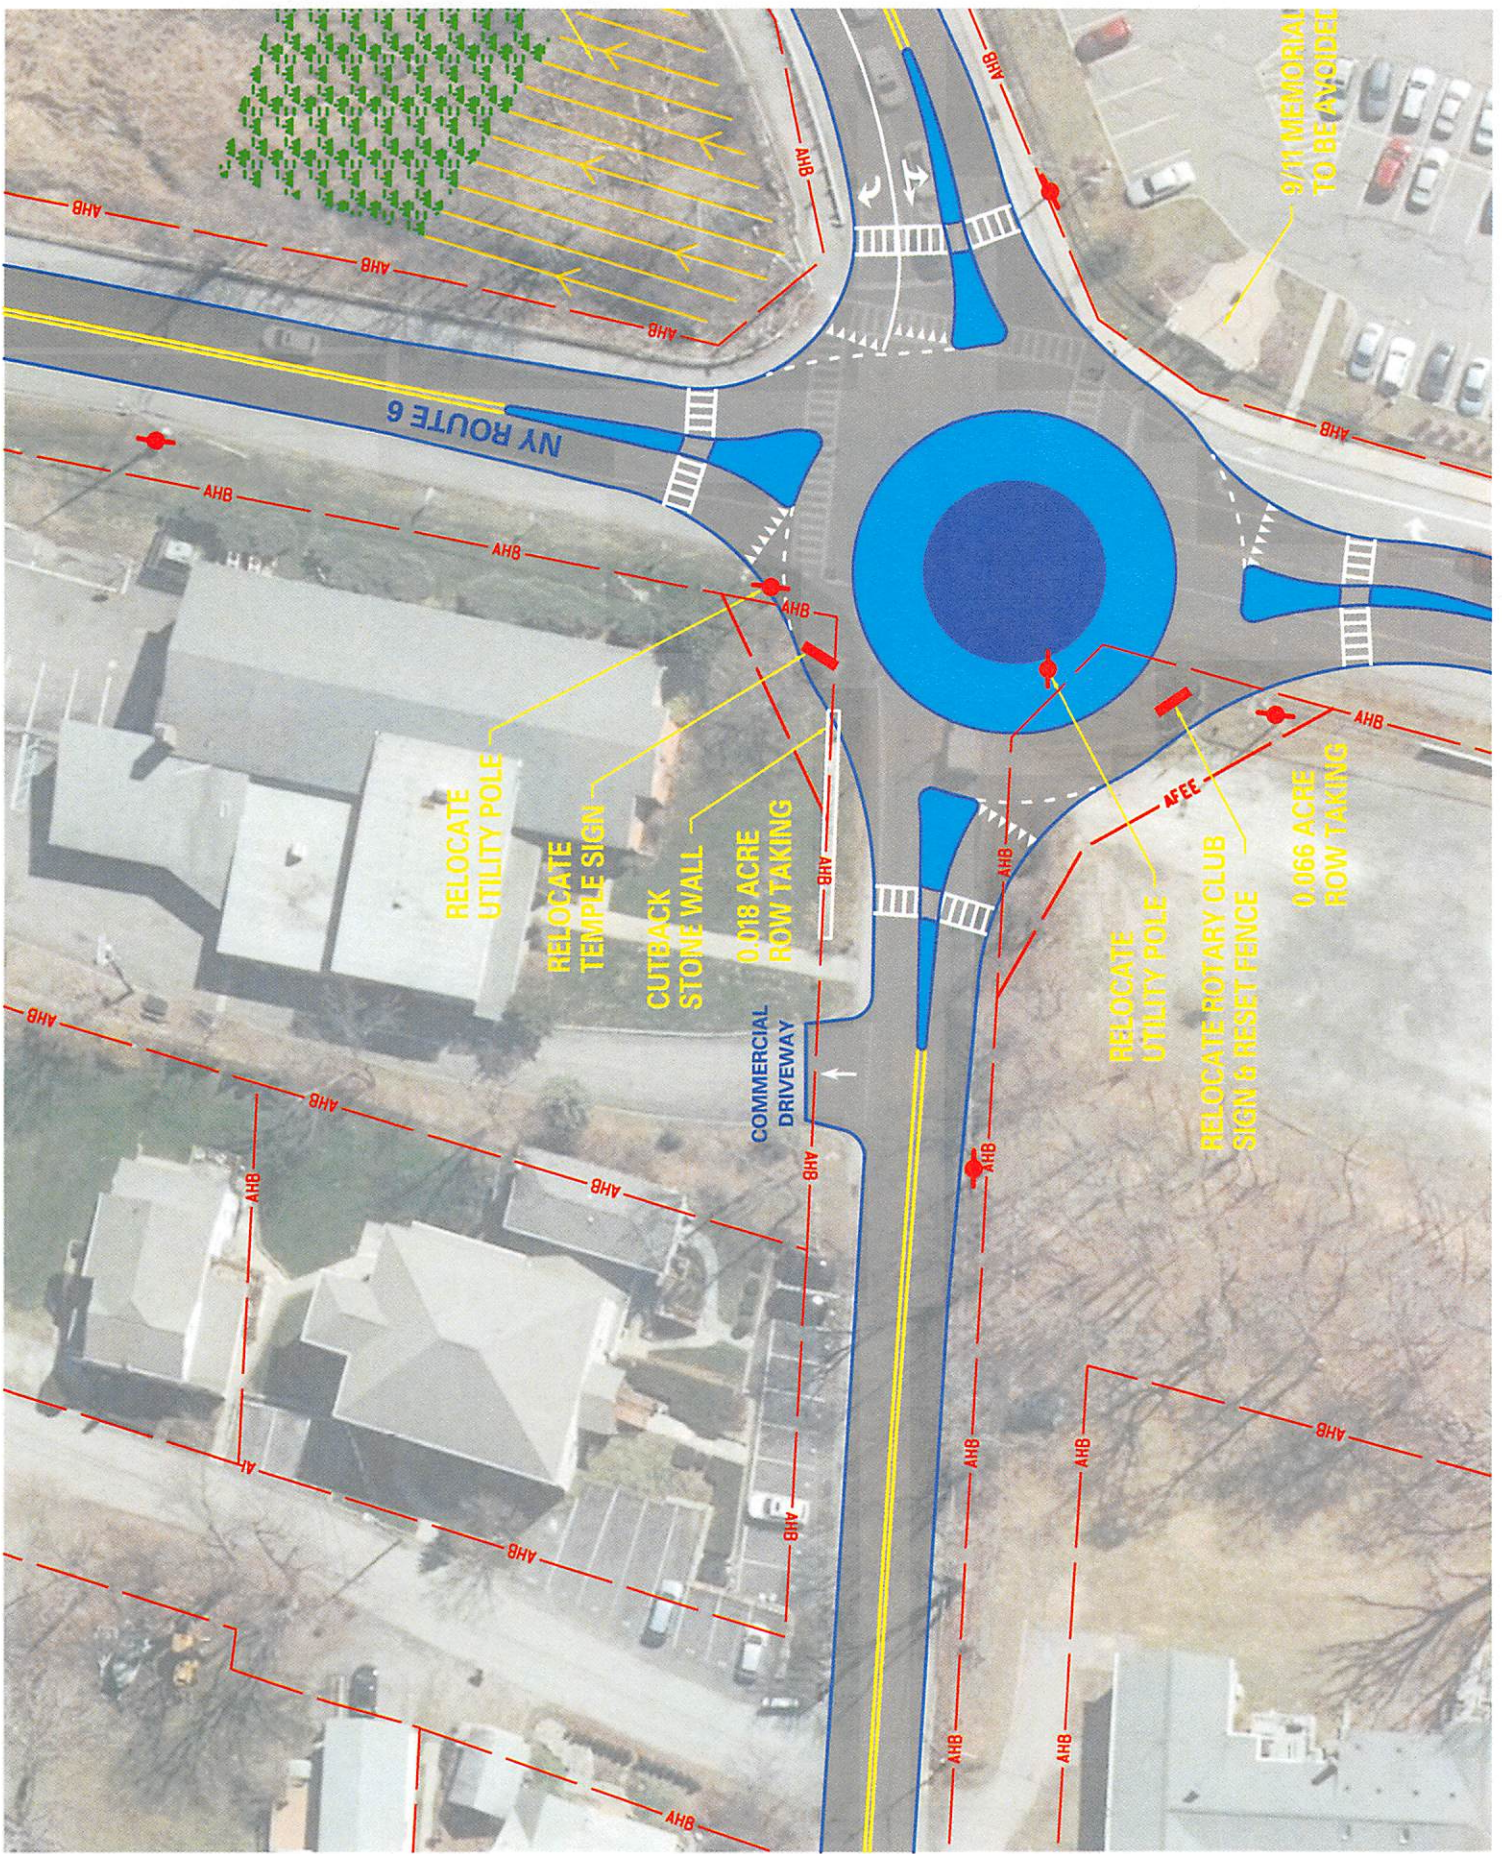
The existing traffic signal provides ample capacity and the analysis showed no operational issues. However, if a change in traffic control were desired, a roundabout does appear feasible, though it would require a westbound right turn lane be added to the single lane roundabout, and would come uncomfortably close to the Temple building on the northwest corner. Additionally, if constructed, a roundabout would actually worsen the level of service, dropping it from the existing LOS B to LOS C in both AM and PM peak periods. A concept sketch showing the roundabout alternative is included later under this tab.
